# **Silver Lake Improvement Feasibility Study and 5-Year Management Plan Oceana County, Michigan**

**Provided for the: Silver Lake Improvement Board  
Pursuant to P.A. 451 of 1994 as amended**

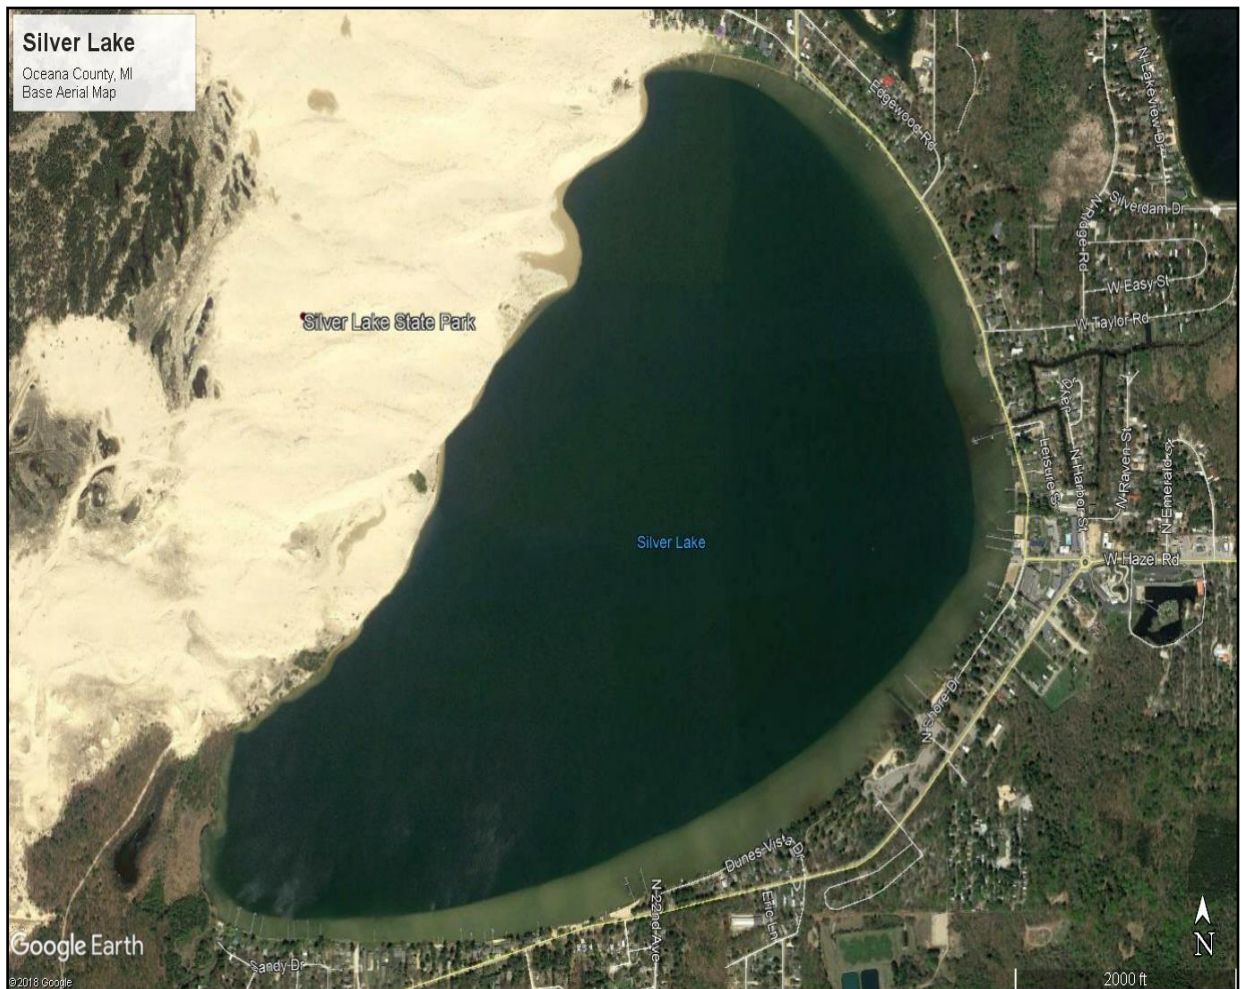
Figure 1. Aerial photo of Silver Lake, Golden Township, Oceana County, Michigan.

Silver Lake is located in Sections 19, 20, 29, 30, and 31 of Golden Township, Oceana County, Michigan (T.15N, R.18W). The lake is comprised of 679.2 acres (RLS, 2022 bathymetric data) and is the center of a recreational community as the west shore of the lake is bordered by sand dunes that abut Lake Michigan (Figure 1). The lake was reported to have a surface area of 690 acres in 1950 but has been reduced in size due to migration of the nearby dunes. Silver Lake is a natural lake with a dam located at the southwest corner and has three areas of water influx which include a spring located at the northeast corner, the Hunter Creek inlet at the east shore, and a small inlet located on the south shore near the Silver Lake State Park. Springs and runoff from wetlands also contribute water sources to the lake.

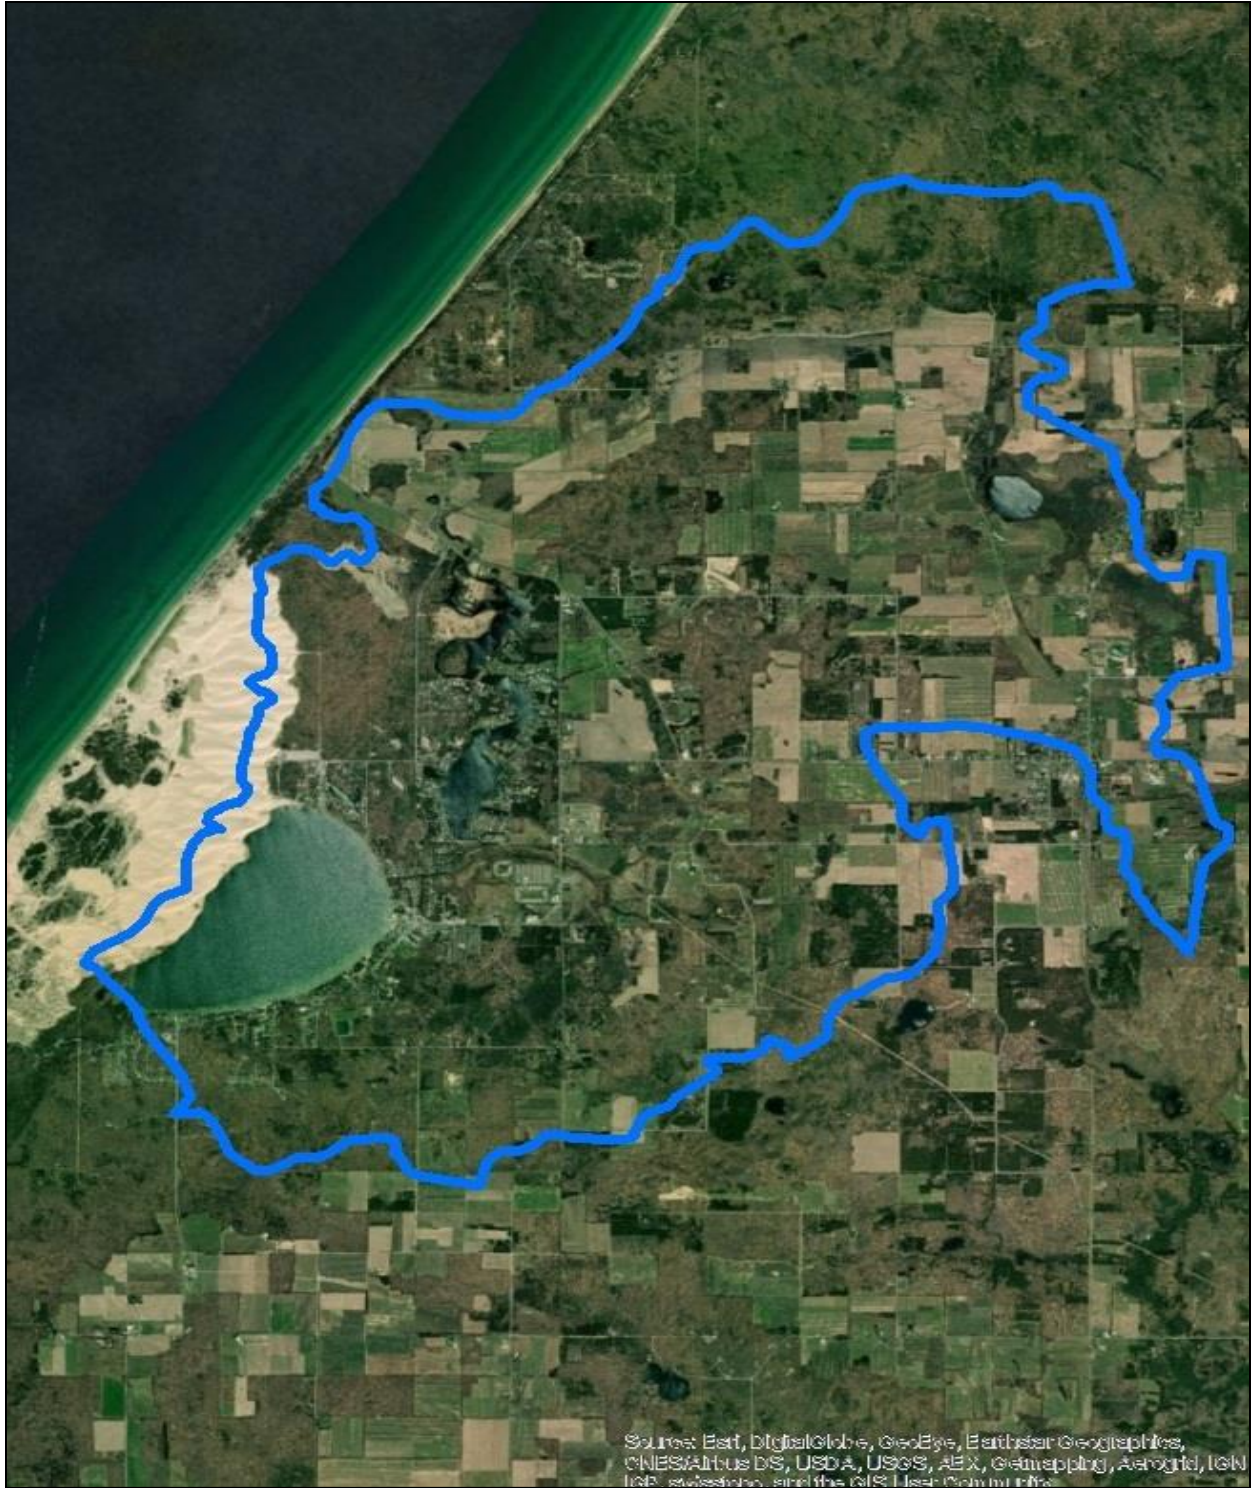
Silver Lake's immediate watershed consists of the area around the lake which directly drains to the lake and measures approximately 12,384 acres (19.4 mi<sup>2</sup>) in size (Figure 4; RLS, 2022).

**Figure 4. Silver Lake immediate watershed boundary (RLS, 2022).**

There are, however, many areas around the lake with significant slopes (>6%). These areas are prone to erosion especially in areas with non-vegetated sands. The immediate watershed is approximately 18.2 times larger than the size of Silver Lake, which indicates the presence of a large-sized immediate watershed. In general, larger watersheds have more opportunities for pollutants, nutrients, and sediments to enter water bodies. Best Management Practices (BMP's) for erosion reduction are offered in the sediment reduction section of this report.

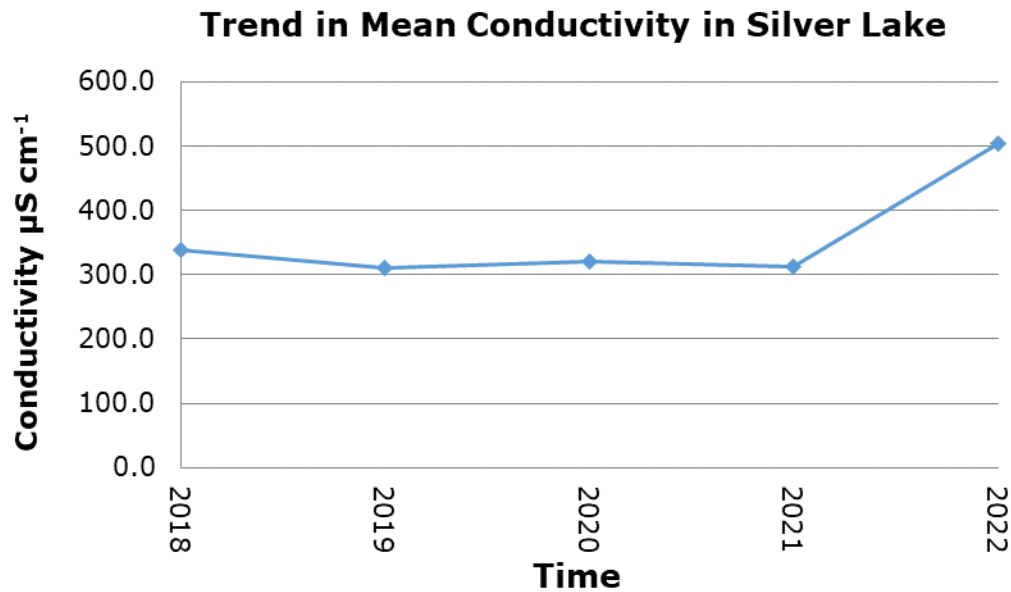
Specific conductivity (abbrev. conductivity) is a measure of the amount of mineral ions present in the water, especially those of salts and other dissolved inorganic substances. Conductivity generally increases with water temperature and the amount of dissolved minerals and salts in a lake. Conductivity was measured in micro Siemens per centimeter ( $\mu\text{S cm}^{-1}$ ) with the use of a calibrated Eureka Manta II<sup>®</sup> conductivity probe and meter. Conductivity values for Silver Lake have been variable among the three basins and have ranged from 300-507  $\text{mS cm}^{-1}$ (Figure 8).

**Figure 8. Trend in mean specific conductivity with time in Silver Lake (2018-2022).**

These values are moderate for an inland lake and mean that the lake water contains ample dissolved metals and ions such as calcium, potassium, sodium, chlorides, sulfate, and carbonate. Baseline parameter data such as conductivity are important to measure the possible influences of land use activities (i.e. road salt influences) on Silver Lake over a long period of time, or to trace the origin of a substance to the lake in an effort to reduce pollutant loading. Elevated conductivity values over 800  $\text{mS cm}^{-1}$  can negatively impact aquatic life. RLS conducted a runoff evaluation in 2022 and determined that the conductivity from runoff was generally higher than ambient mean basin values.

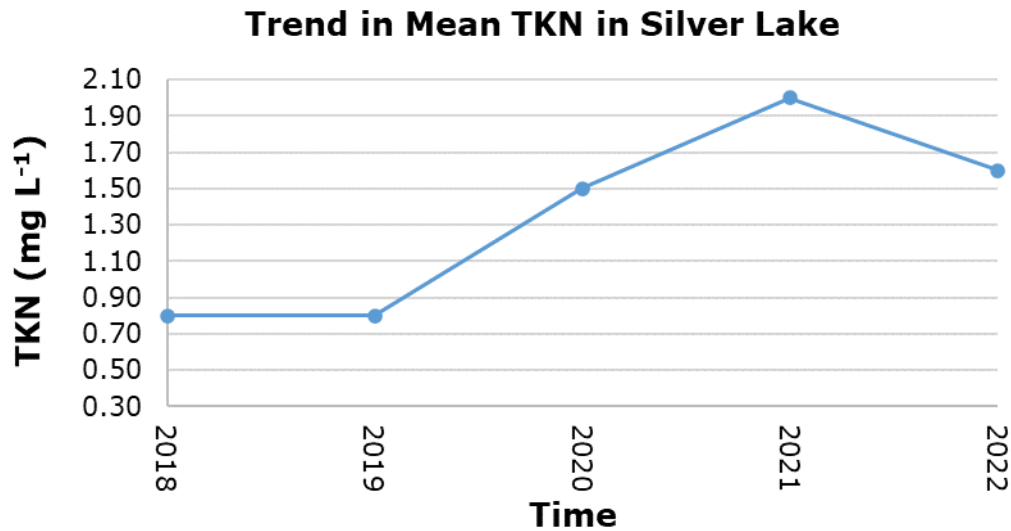
**Figure 11. Trend in mean total Kjeldahl nitrogen (TKN) with time in Silver Lake (2018-2022).**

Total Kjeldahl Nitrogen (TKN) is the sum of inorganic nitrate ( $\text{NO}_3^-$ ), nitrite ( $\text{NO}_2^-$ ), ammonia ( $\text{NH}_4^+$ ), and organic nitrogen forms in freshwater systems. Much nitrogen (amino acids and proteins) also comprises the bulk of living organisms in an aquatic ecosystem. Nitrogen originates from atmospheric inputs (i.e., burning of fossil fuels), wastewater sources from developed areas (i.e., runoff from fertilized lawns), agricultural lands, septic systems, and from waterfowl droppings. It also enters lakes through groundwater or surface drainage, drainage from marshes and wetlands, or from precipitation (Wetzel, 2001). In lakes with an abundance of nitrogen such as Silver Lake (mean N: P = 36 mg L<sup>-1</sup>), phosphorus is the limiting nutrient for phytoplankton and aquatic macrophyte growth. Lakes with a mean TKN value of 0.66 mg L<sup>-1</sup> may be classified as oligotrophic, those with a mean TKN value of 0.75 mg L<sup>-1</sup> may be classified as mesotrophic, and those with a mean TKN value greater than 1.88 mg L<sup>-1</sup> may be classified as eutrophic. Silver Lake contains moderate values for TKN at all depths (0.8-2.0 mg L<sup>-1</sup>), which is normal for an inland lake of similar size and demonstrates that the lake is phosphorus limited (dominant in nitrogen; Figure 11). Thus, any additional inputs of phosphorus would lead to increased aquatic plant and algae growth. In the absence of dissolved oxygen, nitrogen is usually in the ammonia form and will contribute to rigorous milfoil growth.

The total inorganic nitrogen (TIN) consists of nitrate, nitrite, and ammonia forms without the organic forms of nitrogen. Based on the proportions of TIN and TKN, the samples indicate that between 17-92% of the total nitrogen consists of nitrate and the remainder of each sample was in the ammonia form.

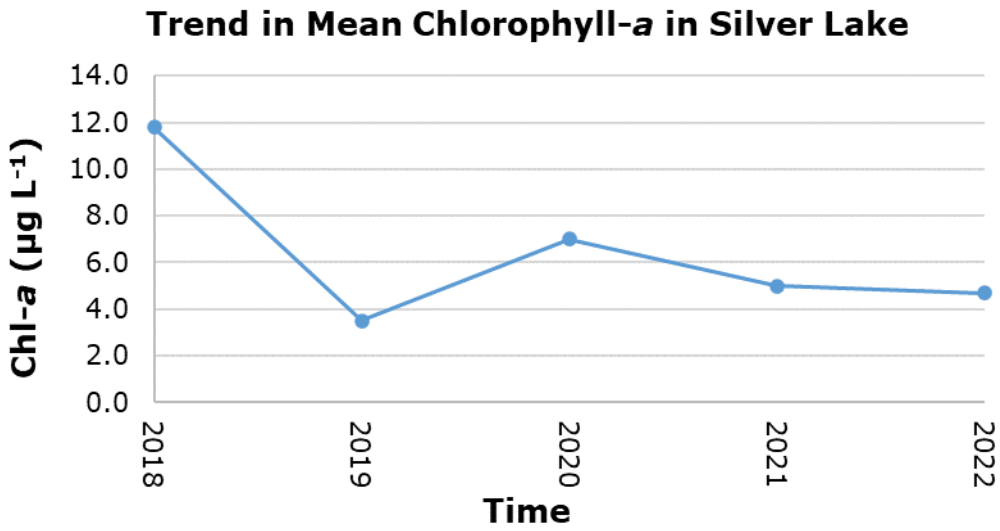
Chlorophyll-*a* is a measure of the amount of green plant pigment present in the water, often in the form of planktonic algae. High chlorophyll-*a* concentrations are indicative of nutrient-enriched lakes. Chlorophyll-*a* concentrations greater than 6  $\mu\text{g L}^{-1}$  are found in eutrophic or nutrient-enriched aquatic systems, whereas chlorophyll-*a* concentrations less than 2.2  $\mu\text{g L}^{-1}$  are found in nutrient-poor or oligotrophic lakes. Chlorophyll-*a* was measured in micrograms per liter ( $\mu\text{g L}^{-1}$ ) with the use of an acetone extraction method and a spectrometer. The chlorophyll-*a* concentrations in Silver Lake were determined by collecting a composite sample of the algae throughout the water column at each of three basin sites from just above the lake bottom to the lake surface. Chlorophyll-*a* concentrations were negative, but the pheophytin-*a* concentrations were around 11.8  $\mu\text{g L}^{-1}$  which is quite high and indicates that the central magnesium ( $\text{Mg}^{+2}$ ) atom that is found in chlorophyll and green algae was lacking. Concentrations have ranged from 3.8-12  $\mu\text{g L}^{-1}$  (Figure 12) in recent and past years, which is elevated.

Figure 12. Trend in mean chlorophyll-*a* (Chl-*a*) with time in Silver Lake (2018-2022).

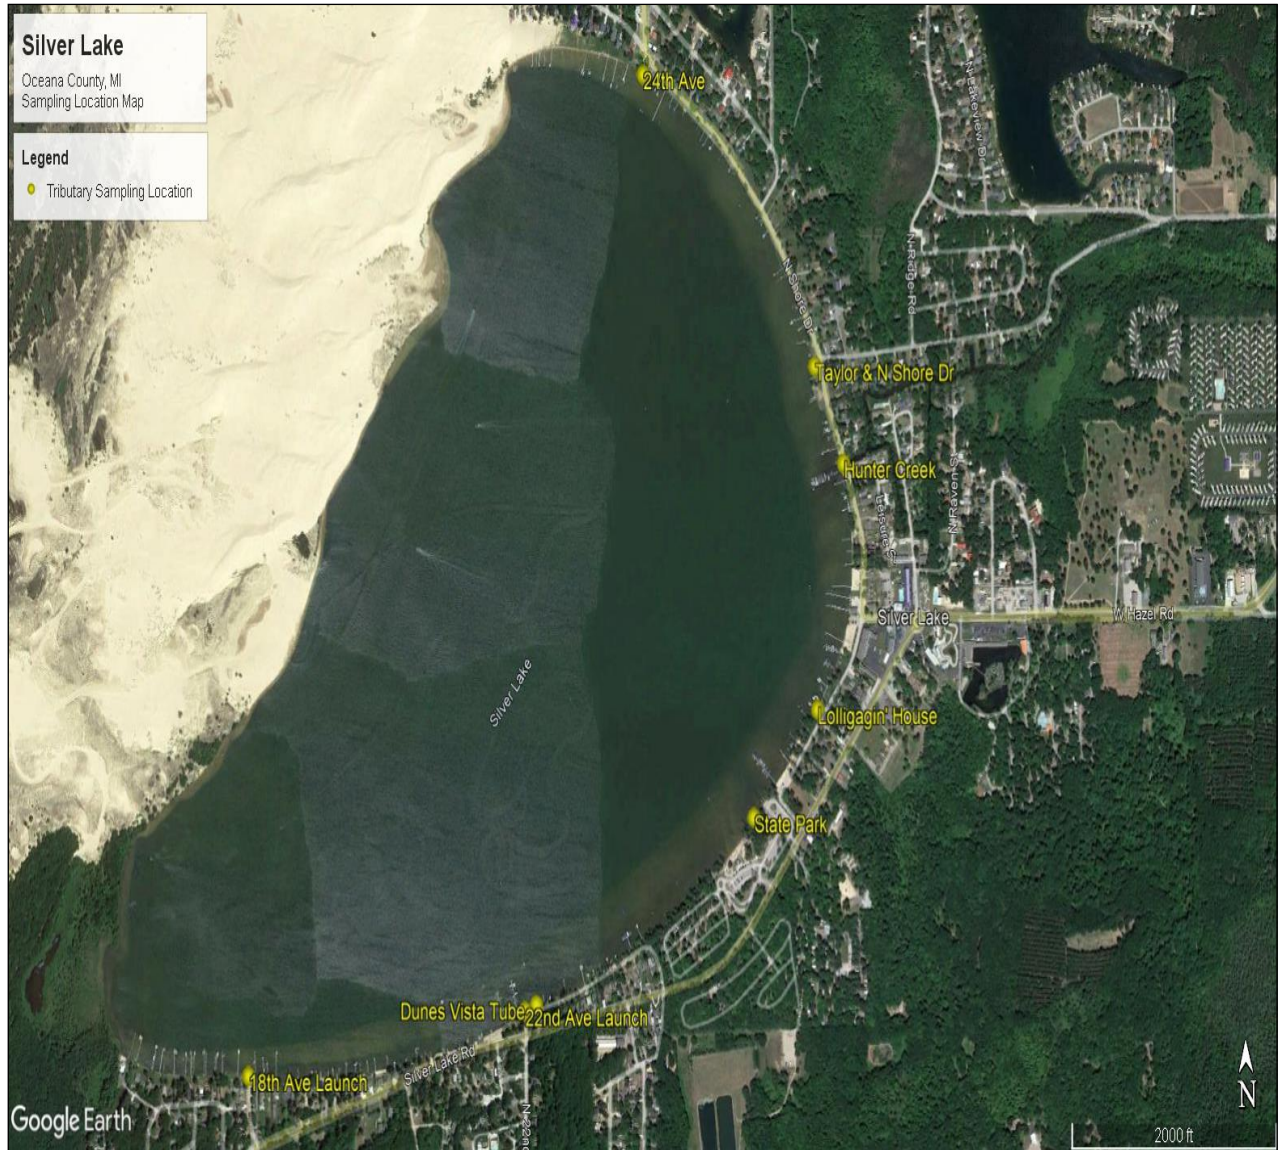
**Figure 16. Locations for runoff water quality sampling in Silver Lake (April-September, 2022).**

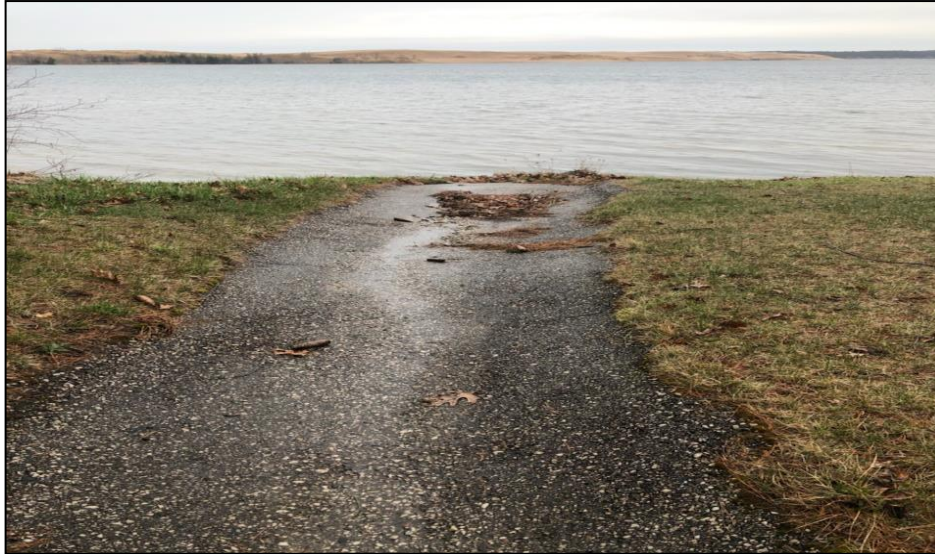
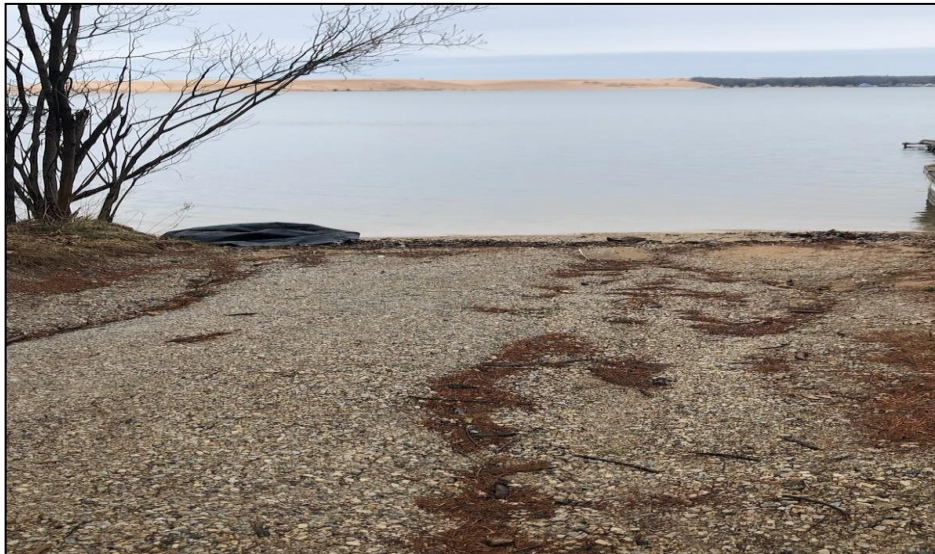
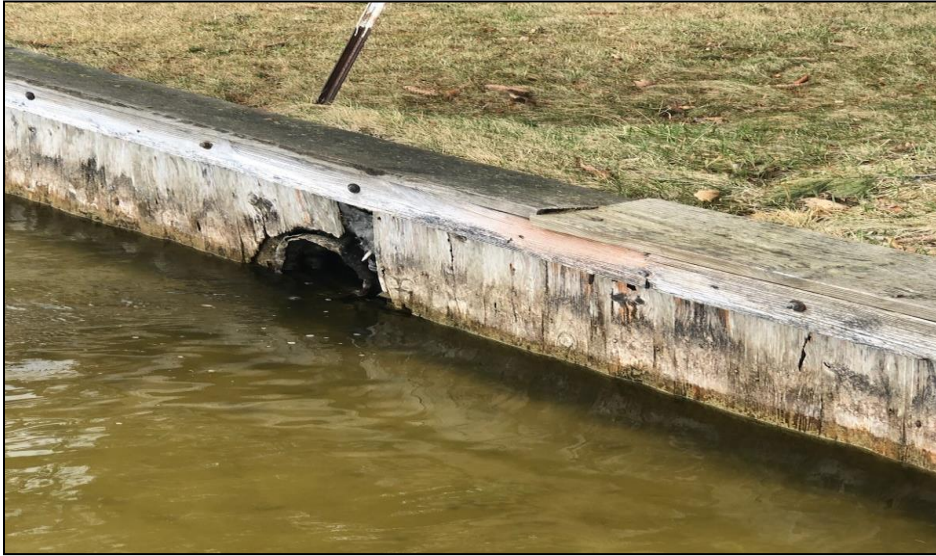
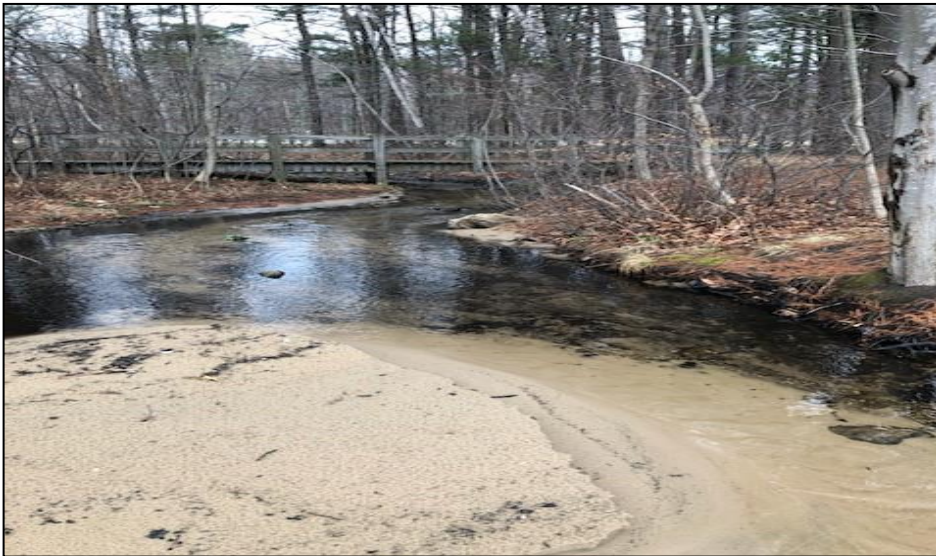
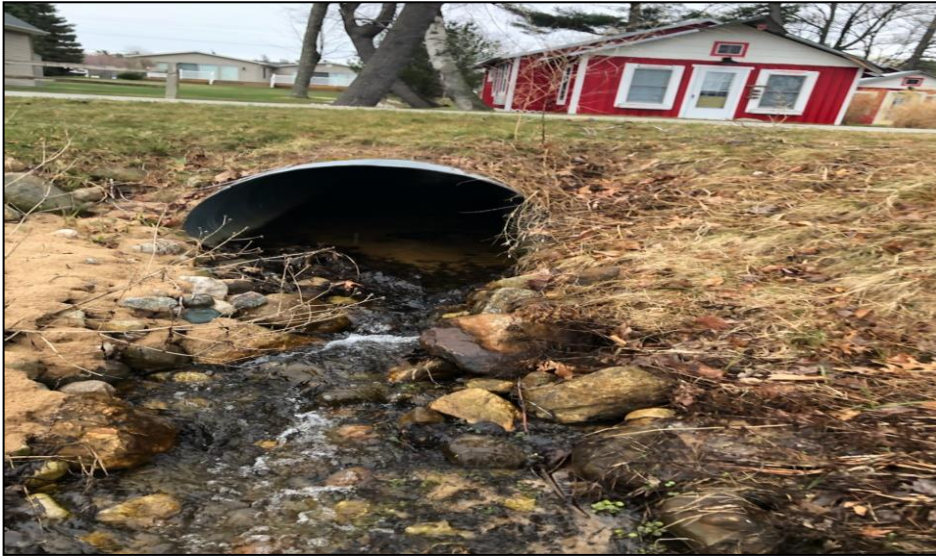
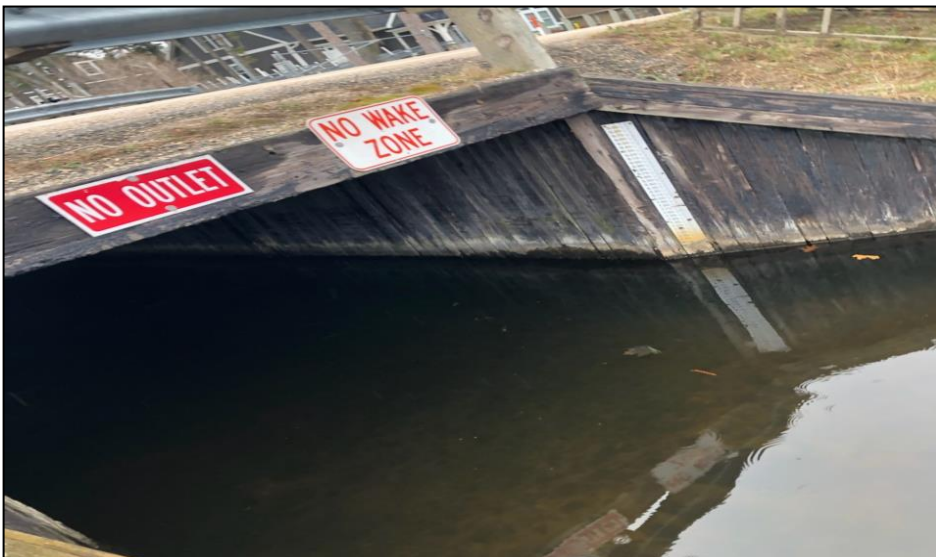
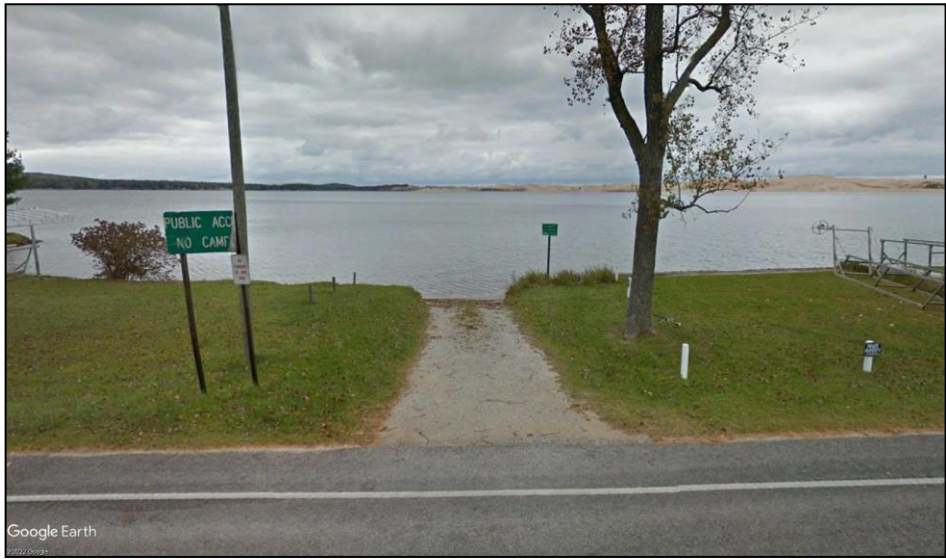
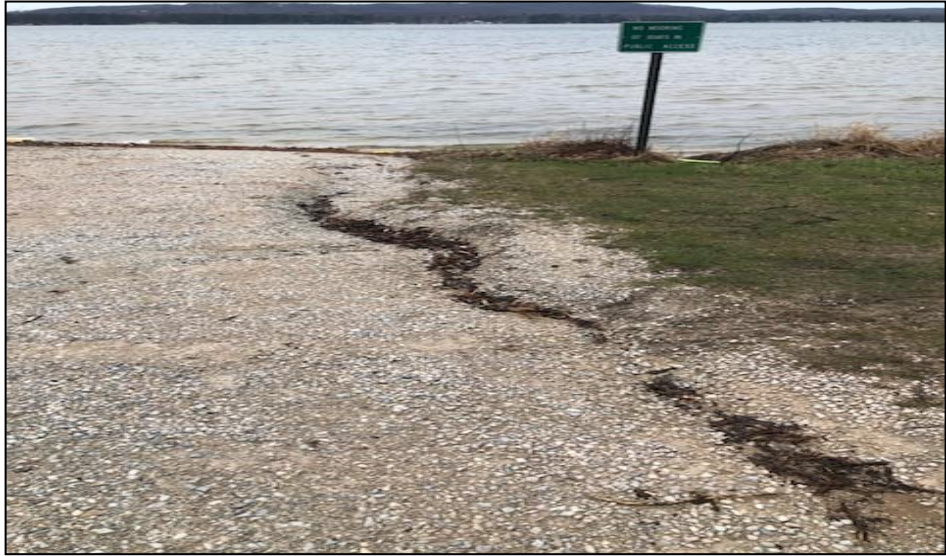
The physical parameters measured at the runoff sites were similar to those measured in the lake basin, with some additional parameters specific for runoff. Figures 18-25 below display the specific sites where significant runoff and gully erosion were noted.

This type of erosion was found at the 18<sup>th</sup> Ave, 22<sup>nd</sup> Ave, 24<sup>th</sup> and 26<sup>th</sup> Ave Ramps. Neighborhood or unhardened private boat launch areas can contribute significant amounts of sediment to the lake over time. Sheet, rill, and gully erosion occurs on these sites because of the lack of vegetation, compaction due to being driven on, and lack of a properly hardened surface. Often times these areas start with minor amounts of sheet erosion, which concentrates into rill erosion (3 inch or deeper gullies forming a parallel or dendritic pattern) and finally if not addressed into deep gully erosion. All boat launches, by nature, slope to the lake and can be excellent conduits for sediment delivery to the lake.

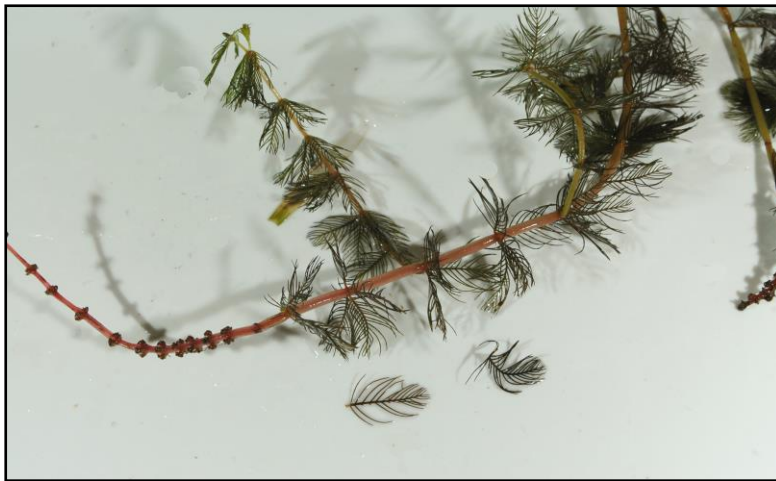
**Figure 26. Photo of Eurasian Watermilfoil ©RLS**

Eurasian Watermilfoil (*Myriophyllum spicatum*; Figure 26) is an exotic aquatic macrophyte first documented in the United States in the 1880's (Reed 1997), although other reports (Couch and Nelson 1985) suggest it was first found in the 1940's. Eurasian Watermilfoil has since spread to thousands of inland lakes in various states through the use of boats and trailers, waterfowl, seed dispersal, and intentional introduction for fish habitat. Eurasian Watermilfoil is a major threat to the ecological balance of an aquatic ecosystem through causation of significant declines in favorable native vegetation within lakes (Madsen et al. 1991), and may limit light from reaching native aquatic plant species (Newroth 1985; Aiken et al. 1979). Additionally, Eurasian Watermilfoil can alter the macroinvertebrate populations associated with particular native plants of certain structural architecture (Newroth 1985).

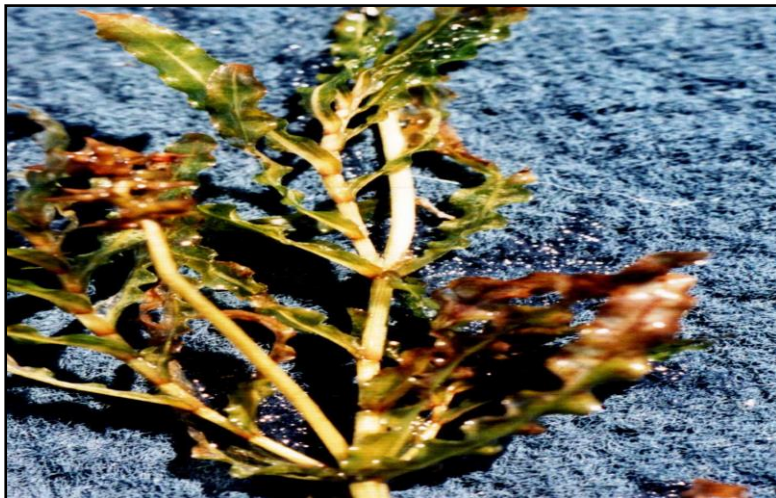
**Figure 27. Photo of Curly-leaf Pondweed ©RLS**

Curly-leaf Pondweed (*Potamogeton crispus*; Figure 27) is an exotic, submersed, rooted aquatic plant that was introduced into the United States in 1807 but was abundant by the early 1900's. It is easily distinguished from other native pondweeds by its wavy leaf margins. It grows early in the spring and as a result may prevent other favorable native aquatic species from germinating. The plant reproduces by the formation of fruiting structures called turions.

The plant does not reproduce by fragmentation as milfoil does; however, the turions may be deposited into the lake sediment and germinate in following seasons. Fortunately, the plant naturally declines around mid-July in most lakes and thus is not likely to be prolific throughout an entire growing season. Curly-leaf Pondweed is a pioneering aquatic plant species and specializes in colonizing disturbed habitats. It is highly invasive in aquatic ecosystems with low biodiversity and unique sediment characteristics. It was found to occupy approximately a few small areas on the bottom in Hunter Creek, which is a low quantity. At this time, management is not required due to the low abundance of the plant. A list of invasive aquatic plant species found in Silver Lake can be found in Table 5.

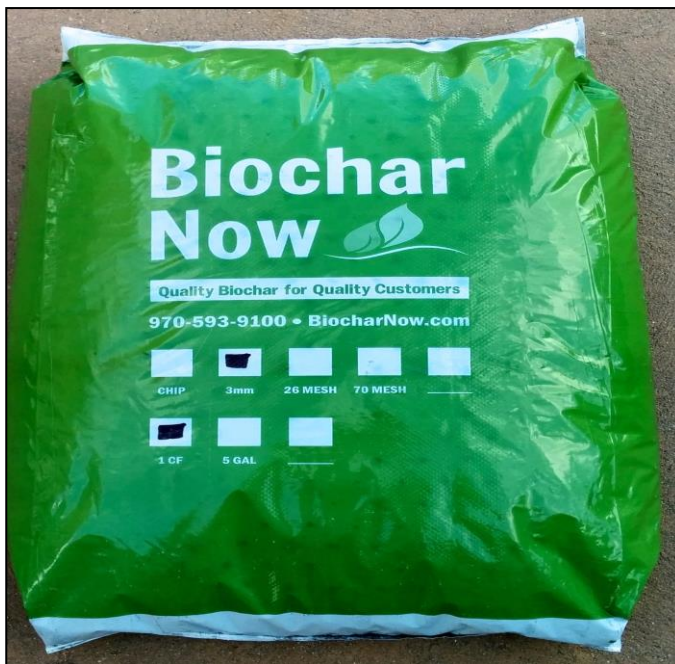
A natural charcoal technology called EarthFood Biochar US<sup>®</sup> is available for filtration of nutrients and pollutants that may enter inland waters such as Silver Lake. The Biochar is comprised of 87.4% organic carbon based on percentage of total dry mass. Particles range in size from 8-25 mm so there is inherent variability in particle size. This variability allows for the adsorption of nutrients and pollutants due to increased adsorptive surface area. Biochar may be placed in a multi-filament polypropylene sock (such as Silt Sock<sup>®</sup>) which has a life expectancy of up to 2 years. It is considered an inert product with no chemical effect on the environment. This product allows for the Biochar to be contained in an area and serves to consolidate the particles for optimum filtration efficiency. Previous data collected by RLS on an inland lake inlet that utilized the Biochar showed significant reductions in nutrients such as phosphorus and nitrogen as well as total suspended solids (Jermalowicz-Jones, 2012-2016).

Figure 41. EarthFood Biochar US<sup>®</sup> product.
