Silver Lake 2023 Aquatic Vegetation, Water Quality, and 2024 Management Recommendations Report with Biochar Efficacy Results

November, 2023

Silver Lake 2023 Aquatic Vegetation, Water Quality, and 2024 Management Recommendations Report with Biochar Efficacy Evaluation

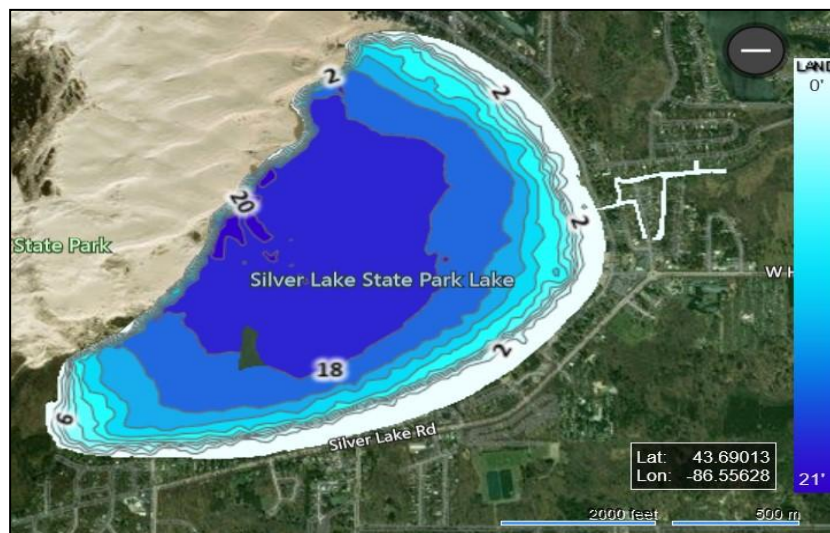
Figure 1. Silver Lake Depth Contours (2023)

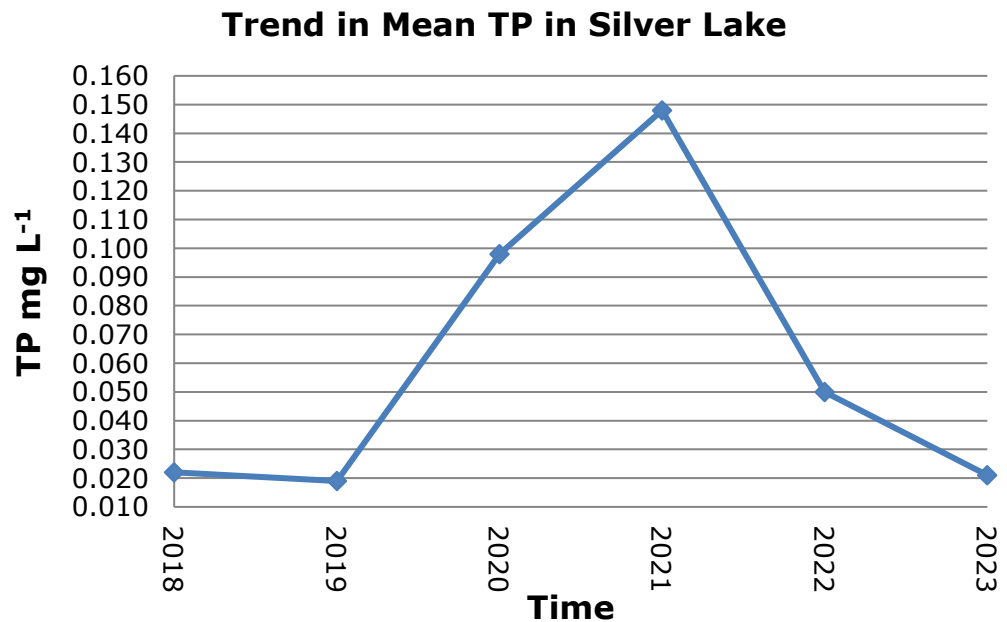
Total phosphorus (TP) is a measure of the amount of phosphorus (P) present in the water column. Phosphorus is the primary nutrient necessary for abundant algae and aquatic plant growth. Lakes which contain greater than 0.020 mg/L of TP are defined as eutrophic or nutrient-enriched. TP concentrations are generally higher at increased depths due to the higher release rates of P from lake sediments under low oxygen (anoxic) conditions. Phosphorus may also be released from sediments as pH increases. Total phosphorus was measured in milligrams per liter (mg/L) with the use of Method EPA 200.7 (Rev. 4.4). **The TP concentrations in the deep basins ranged from 0.016-0.031 mg/L which is much lower than recent years. The mean TP concentration in 2023 was 0.021 mg/L which is favorable and below the eutrophic threshold.** Soluble reactive phosphorus was also measured, and all samples were <0.010 mg/L which is ideal.

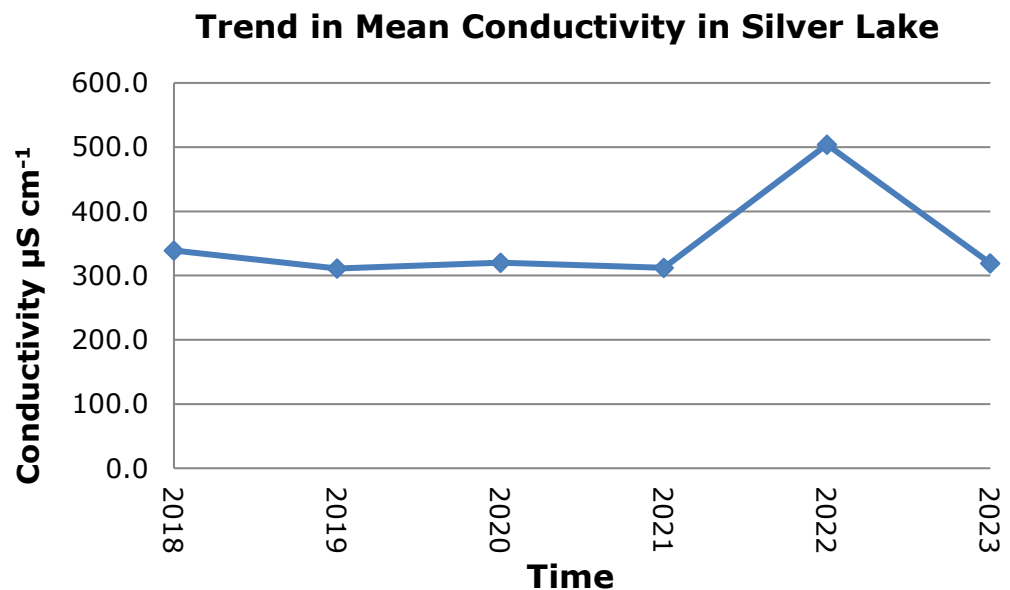
Conductivity is a measure of the number of mineral ions present in the water, especially those of salts and other dissolved inorganic substances and was measured with a calibrated Eureka Manta II® multi-parameter sonde. Conductivity generally increases as the amount of dissolved minerals and salts in a lake increases, and also increases as water temperature increases. **The conductivity values for Silver Lake during the 2023 sampling event were moderate and ranged from 308-516 $\mu\text{S}/\text{cm}$ with a mean of 319 $\mu\text{S}/\text{cm}$ which is moderate and favorable and lower than in 2022 due to less runoff.** Severe water quality impairments do not occur until values exceed 800 $\mu\text{S}/\text{cm}$ and are toxic to aquatic life around 1,000 $\mu\text{S}/\text{cm}$.

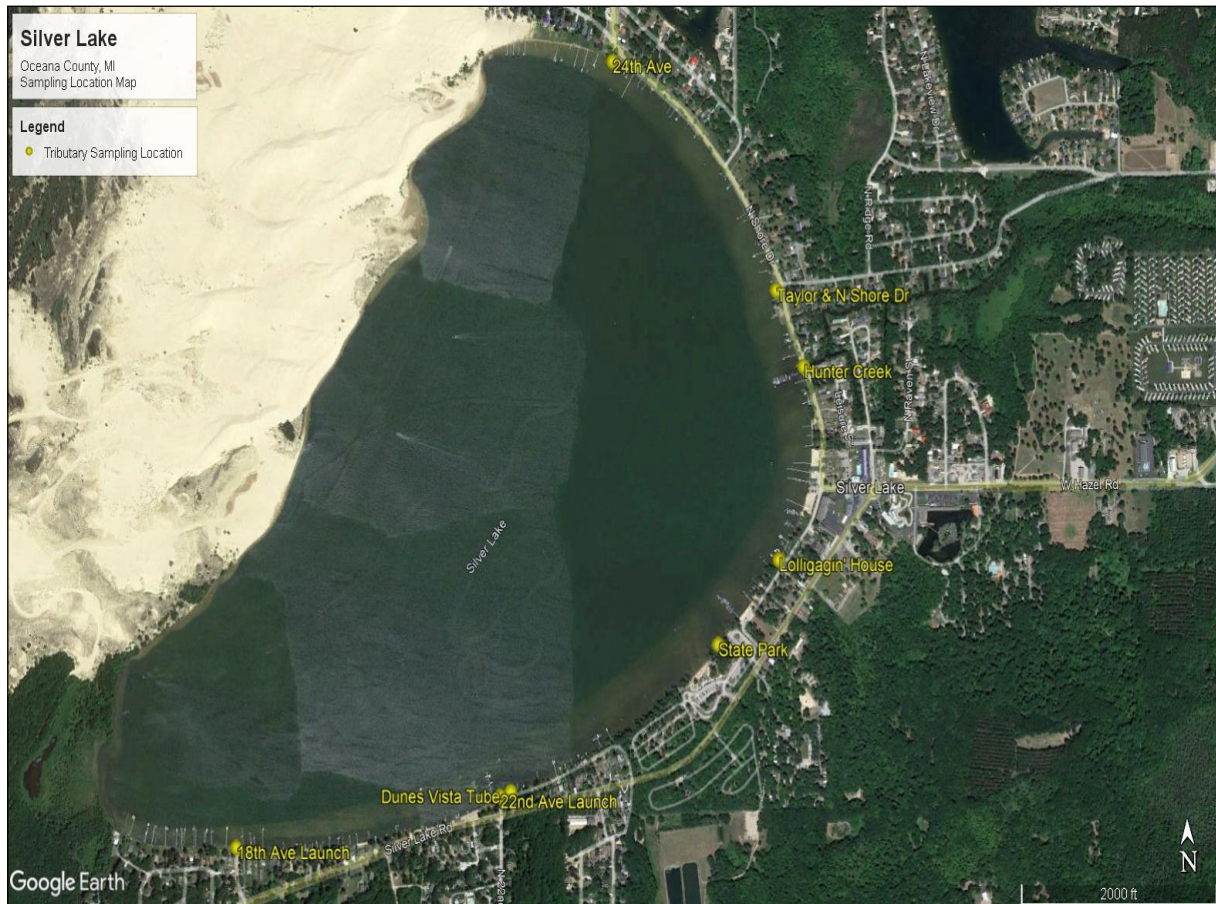
Figure 3. Silver Lake drain sampling location map (2022-2023). Note: During both years only flowing drains could be sampled.

A total of N=8 water quality sampling sites were originally selected based on pre-sampling evaluation of sediment plumes entering the lake during an intense rainfall event in the fall of 2021 (Figure 3). Based on this event, the sites selected were determined to contribute significant quantities of water to the lake. Due to the ongoing increases in nutrients and solids within the lake over time, there was a great need to understand the origins of these non-point source pollutants. **Both septic systems and drain runoff contribute to the nutrient loads in Silver Lake. In 2022, the magnitude of pollutant contributions to the lake was determined and it was recommended that all critical drains have EarthFood Biochar filters installed. These filters were permitted by EGLE and were installed in June 2023. Post-biochar monitoring required all filters to be in place and have ample water flow. Qualified flow was determined on two dates prior to the seasonal removal of the filters and included August 6, 2023 and September 6, 2023.** The data below display all water quality parameters measured along with means and standard deviations for those parameters. The water quality parameters measured with a calibrated Eureka Manta II® multi-meter probe with parameter electrodes included the following:

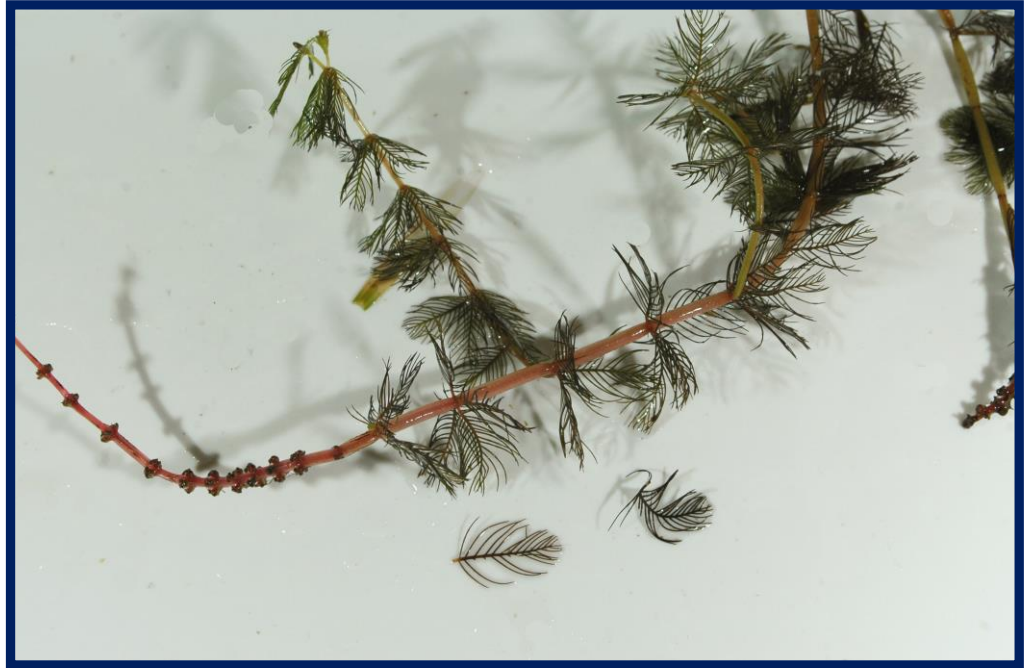
Figure 6. Eurasian Watermilfoil (*Myriophyllum spicatum*)

The amount of Eurasian Watermilfoil (Figure 6) present in Silver Lake varies each year and is dependent upon climatic conditions, especially runoff-associated nutrients. **The June 20, 2023 survey revealed that approximately 5 locations of milfoil were found throughout the entire lake at the “a” or low abundance level. In addition, there was the presence of another invasive species, Curly-leaf Pondweed (Figure 7) which was found in 13 locations within the lake at the “a” and “b” low abundance levels. Currently, both invasives are welcomed habitat for the fishery but are being monitored for any aggressive invasion or growth. Figure 8 shows the current biovolume of submersed aquatic vegetation in the lake which is still low but higher than in previous years. It must continue to increase to assist in the reduction of blue-green algae in the lake, as this algae competes with submersed aquatic vegetation for nutrients. The clarity of the lake has been reduced by runoff, blue-green algae, and bottom-feeding carp but these issues are being addressed and the water clarity is improving and should continue to improve. No treatments were needed in 2020-2023 due to lack of milfoil growth and the need for some vegetative cover. The MDNR report (2020-001) by Mark A. Tonello recommended no further treatments at this time. RLS agrees with this recommendation; however, if milfoil is determined to be an imminent threat to the ecology of Silver Lake through development of dense beds that form canopies that may fragment, then RLS will recommend management of those localized beds to reduce the threats of spreading. RLS will carefully monitor the lake again next year for any possible invasions.**

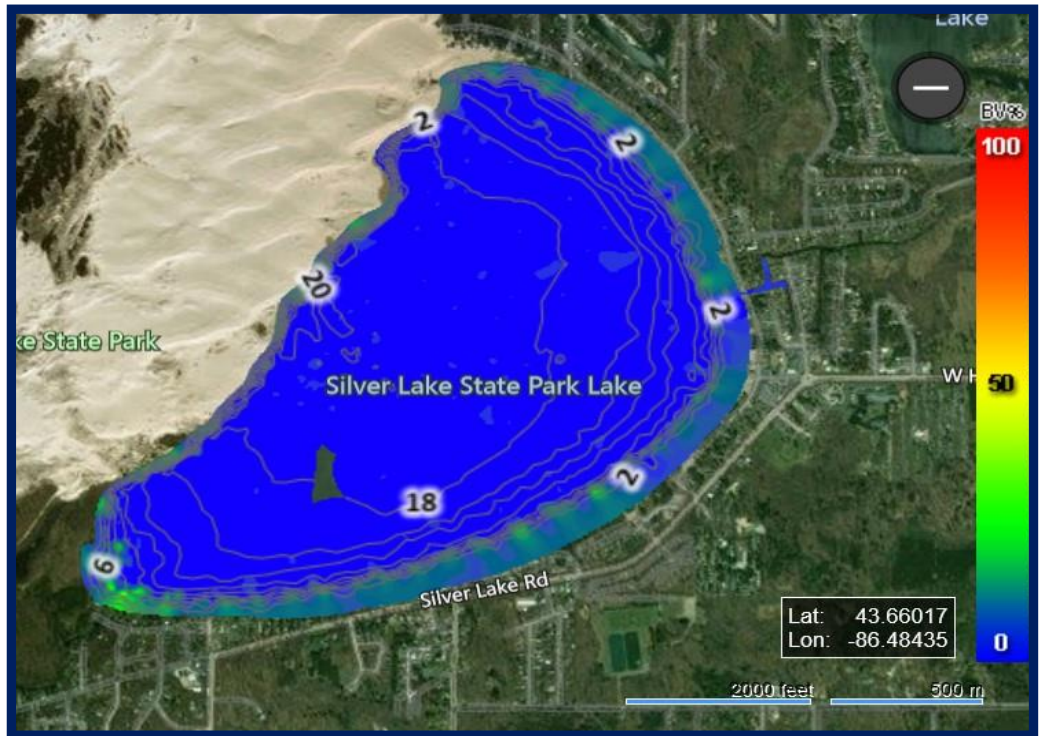
Figure 8. Aquatic Vegetation biovolume in Silver Lake (June 20, 2023).
